7.5.2 Chernobyl

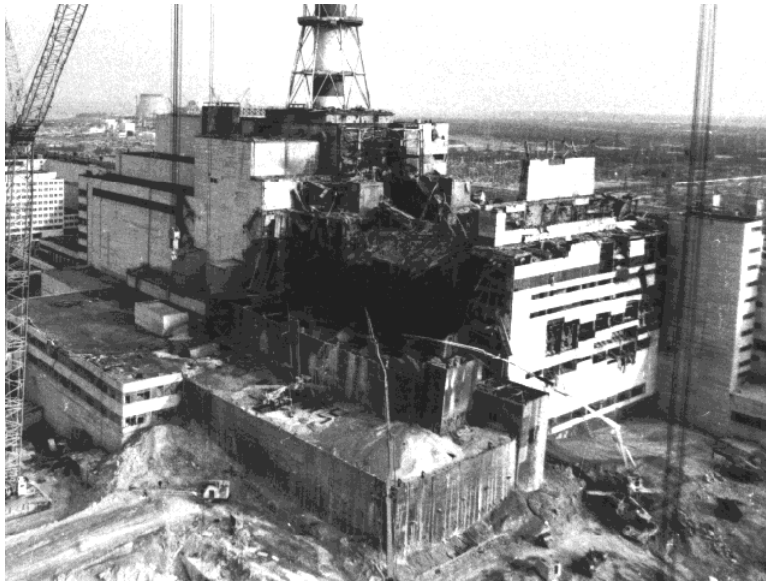
Figure 2: Photograph of the Chernobyl accident site taken shortly after the accident (USNRC 2006).

a huge steam explosion (see section 7.6.4) that lifted the top off the reactor, blew off the building roof and sent a plume of radioactive gases and particulates high into the atmosphere. The intense fire in and exposure of the nuclear core not only resulted in destruction of the reactor and the death of 56 people but also caused radiation sickness in another 200-300 workers and firemen. It also contaminated a large area in Ukraine and the neighboring country of Belarus (see figure 3). It is estimated that 130,000 people in the vicinity of the reactor received radiation above international limits. The photograph in figure 2 demonstrates how extensive the damage was to the reactor building.

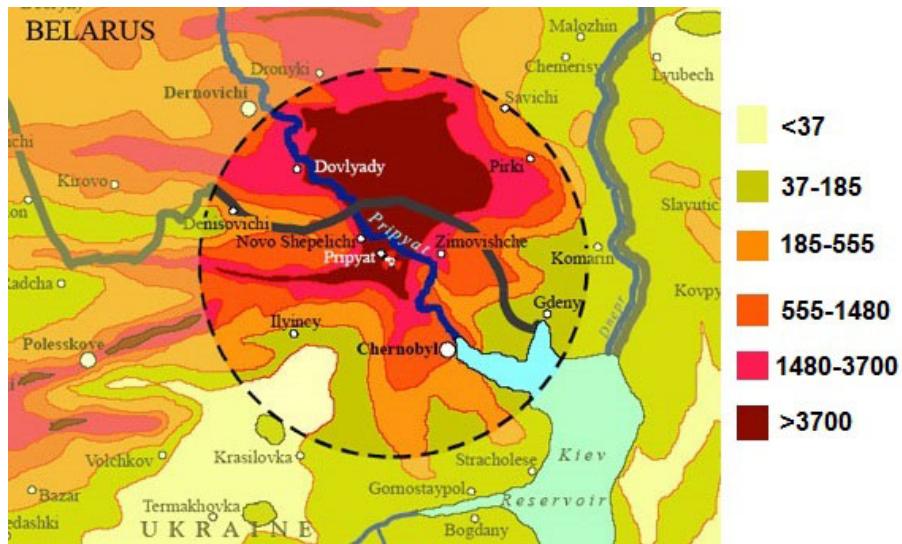
Figure 3: Map of the radioactive deposits (radioactivity of ^{137}Cs in the soil in kBq/m^2) on Apr.27, 1986, and the 30 km exclusion zone around the Chernobyl reactor (UNSCEAR 2000).

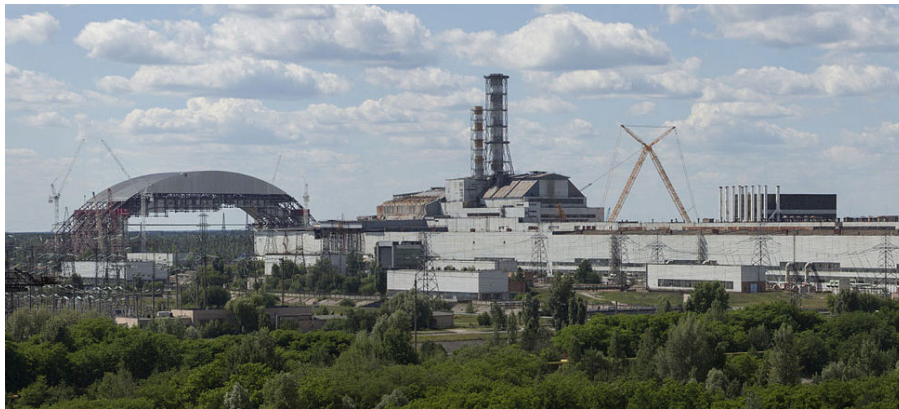
Figure 4: Cylindrical entombment structure (left) being prepared for installation over the damaged Chernobyl reactor (center). Photograph reproduced with the permission of the owner, Ingmar Runge.

This reactor not only did not have a secondary containment structure that might have prevented much death, injury and contamination but it was also of the type that could have a positive void coefficient (see section 7.1.2) that may or may not have been a factor during the lead-up to the fuel disintegration. Eventually, with great difficulty and with considerable risk to human life, the remains of the reactor were covered in concrete. Plans to enclose the whole mess with an additional 107 *m* tall, semi-cylindrical containment building that will be slid over the top of the damaged reactor building are currently underway (see figure 4).
